UNITED STATES ENVIRONMENTAL PROTECTION AGENCY

**RE: Request for Information (“RFI”) Pursuant to Section 308 of the Clean Water Act
Docket No. CWA-IR-16-009
On Time Ready Mix Inc. – 34-16 College Point Blvd Facility (NYR00D693)
Compliance Evaluation Inspection conducted on February 1, 2016**

COMPLIANCE EVALUATION INSPECTION REPORT

Compliance Evaluation Inspection: On Time Ready Mix Inc.	
Inspection Date: February 1, 2016	EPA Inspectors: Kimberly McEathron, Physical Scientist, USEPA Region 2, (212) 637-4228; and Cyndy Kopitsky, Physical Scientist, USEPA Region 2, (212) 637-3832
Inspection Time: 9:40 AM – 10:50 AM	
On-Site Representatives: Rocco Oppedisano, Plant Manager/Co-Owner, On Time Ready Mix Inc., (718) 961-3338; and Helen Hu, On Time Ready Mix Inc., (718) 961-3338	
Site Information: Lat / Long: 40.76433, -73.836525 On Time Ready Mix Inc. 34-16 College Point Blvd Flushing, New York 11354 SPDES/ICIS No. NYR00D693	
NAICS/SIC Code: 3273 – Ready-Mixed Concrete

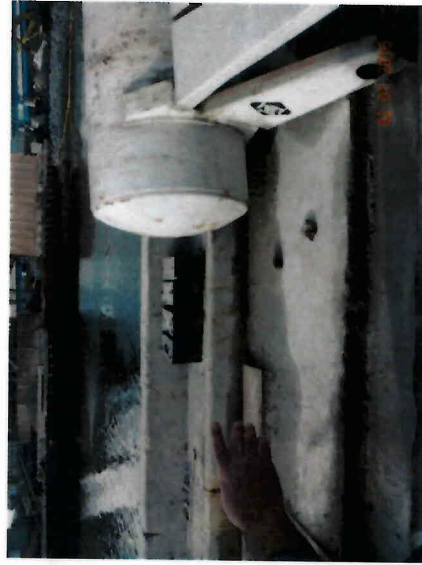
DSCN6143

5. At the time of the inspection, EPA inspector McEathron observed at least seven (7) used batteries being stored exposed to stormwater on the concrete wall along the western edge of the Facility (see photographs DSCN6143.JPG and DSCN6147.JPG). Batteries should be stored indoors to prevent groundwater or stormwater contamination.

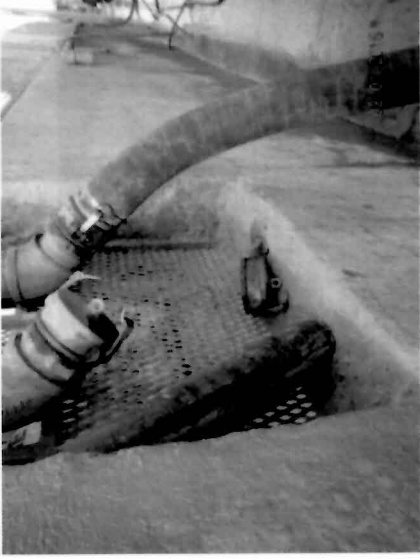
DSCN6156

6. At the time of the inspection, cement powder was observed immediately below the hose hook up at the sidewalk in addition to some white residue extending down from the hose to the sidewalk along College Point Boulevard (see photograph DSCN6156.JPG). The Facility should implement practices designed to prevent spilled material and should clean up any spilled material to prevent stormwater from carrying the material down the public right of way.

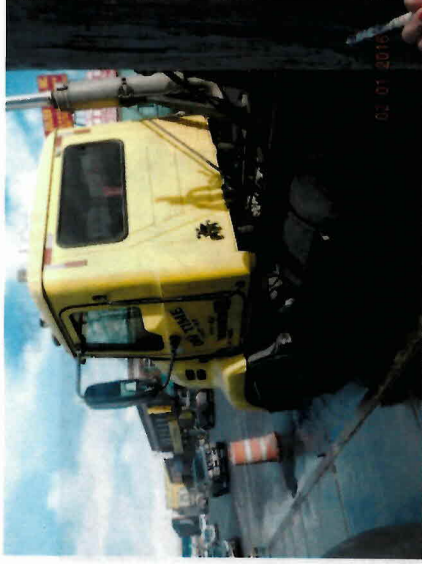
DSCN6158

3. At the time of the inspection, EPA inspector McEathron observed vehicle tracking from the loading area onto College Point Boulevard (see photographs DSCN6162.JPG and DSCN6158.JPG – DSCN6159.JPG). According to Mr. Oppedisano, an on-site sweeper is used to sweep the Facility on a daily basis and is also used to sweep the College Point Boulevard in front of the Facility on a weekly basis, however, the Facility should consider increasing the frequency of sweeping, should document when sweeping is conducted and should implement practices designed to prevent tracking, such as a stone tracking pad.

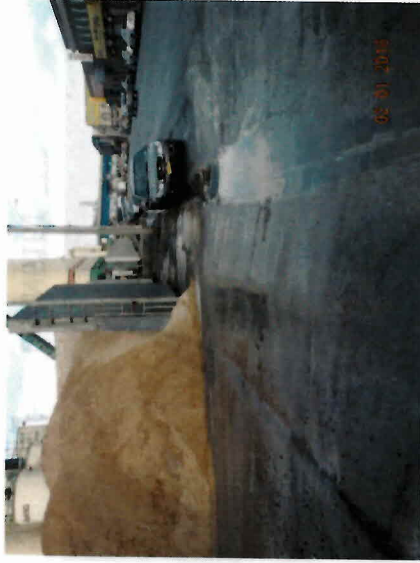
DSCN6159

7. At the time of the inspection, EPA inspector McEathron observed a sand stockpile located in the northeast corner of the Facility which extended onto the driveway towards College Point Boulevard (see photograph DSCN6159.JPG). The Facility should implement practices designed to prevent material from leaving the Facility and should clean up any spilled material to prevent stormwater from carrying the material down the public right of way.

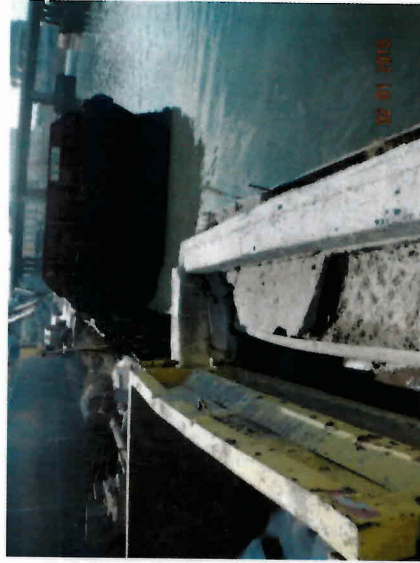
DSCN6167

At the time of the inspection, EPA observed that the concrete wall in the southwest corner was cracked and misaligned into multiple pieces (see photographs DSCN6167.JPG – DSCN6169.JPG and DSCN6172.JPG). EPA did not observe water pooling at or flowing through this location at the time of the inspection. According to Mr. Oppedisano, a barge operating at the Tilcon Facility hit the corner of the wall and damaged it.

1. At the time of the inspection, EPA observed that the concrete wall in the southwest corner was cracked and misaligned into multiple pieces (see photographs DSCN6167.JPG – DSCN6172.JPG). If future conditions at the Facility or surrounding areas, including but not limited to any additional degradation, erosion or damage to the concrete wall located along the western edge of the Facility or should the NYCDEP complete a sewer separation, where the conditions result in a discharge of stormwater or wastewater from the Facility to Flushing Creek, a water of the United States via a point source, NYSDEC SPDES permit coverage for the Facility is required to be obtained prior to discharging, in accordance with Sections 301 and 402(p) of the Clean Water Act.

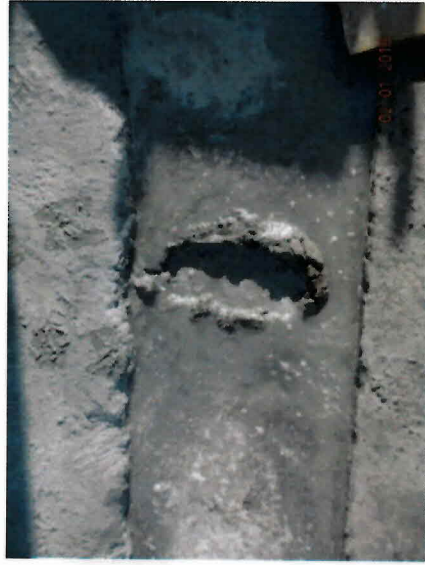
DSCN6174

2. At the time of the inspection, EPA inspector McEathron observed that the stormwater trench was filled with material, resulting in pooling water at the northern end of the trench (see photographs DSCN6174.JPG – DSCN6178.JPG). The trench drainage system should be kept free of material to ensure proper functioning and drainage of the Facility and to reduce the amount of material carried via stormwater to the ready mix concrete truck loading area.

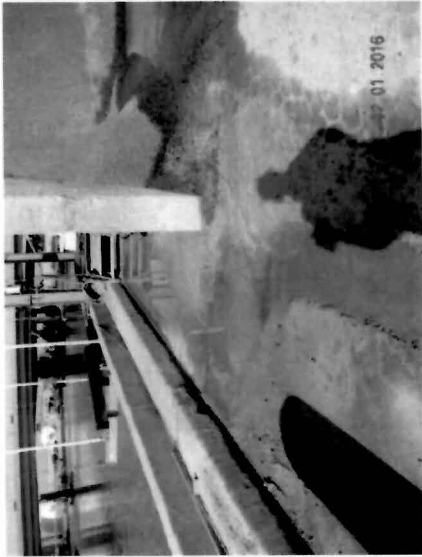
DSCN6177

At the time of the inspection, EPA observed a hole in the concrete wall at the north end of the Facility with pooling turbid water adjacent to it (see photograph DSCN6177.JPG). Utilizing a camera and metal rod, EPA identified that the hole was deeper than the width of the curb (see photographs DSCN6179.JPG – DSCN6182.JPG). At the time of the inspection, EPA observed water dripping into Flushing Creek from this location along the concrete wall and did not observe water dripping from any other location along the wall indicating that water was likely penetrating the wall from the observed hole (see photograph DSCN6183.JPG).

1. Within seven (7) calendar days of receipt of this RFI, On Time Ready Mix Inc. shall submit to EPA a signed written statement certifying that On Time Ready Mix Inc. sealed the hole in the north end of the concrete wall at the Facility adjacent to Flushing Creek as described in the enclosed inspection report; and
2. Within thirty (30) calendar days of receipt of this RFI, On Time Ready Mix Inc. shall submit to EPA a written description with photographic documentation of what measures On Time Ready Mix Inc. has taken to address each of the areas of concern noted in the enclosed inspection report. Specifically, measures to remedy the damaged and deteriorating concrete wall located at the southwest corner of the Facility adjacent to Flushing Creek.

On February 2, 2016, Carla Ragonese of On Time Ready Mix Inc. emailed EPA a photograph and description stating that the hole at the northern end of the concrete wall had been filled in.
